## MEMORANDUM

**Date:** October 19, 2023  
**To:** Competition File, World's Championship Horse Show  
**From:** Debbie Saliling, USEF Director of Compliance & Caroline Jennings, USEF Compliance Liaison  
**Re:** Compliance Inspection – World's Championship Horse Show – August 19-26, 2023 (#335)

**Images: World's Championship Horse Show (#335); August 19-26, 2023**

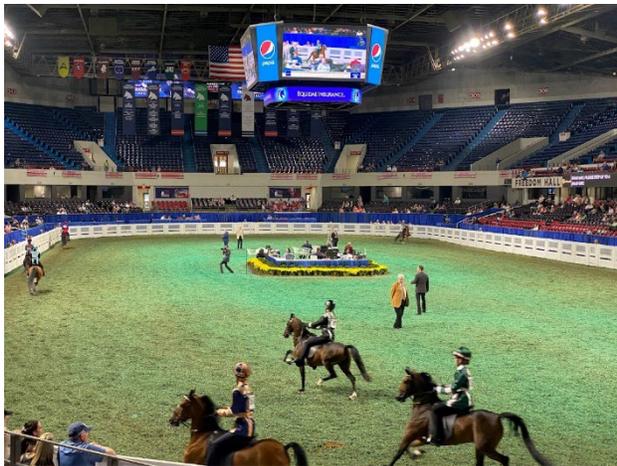
**Image 1: Freedom Hall**

- **Footing:** The sole competition arena is located inside Freedom Hall. The footing is a clay base topped with traditional green sawdust and we understood it was maintained prior to the morning and evening sessions (Image 1). Exhibitors shared that the competition arena footing was suitable for the level of competition taking place at this event.

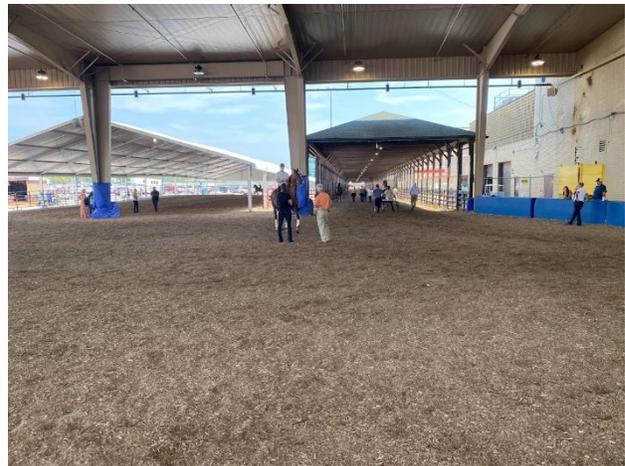
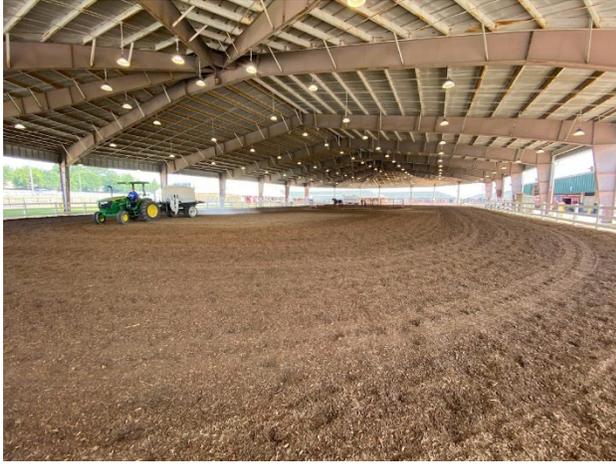
**Image 2: View inside the make-up area looking down Stoper Walk toward permanent stabling**

There were three areas available for warm-up and exercising: Stopher Walk, the make-up ring which is immediately outside of Freedom Hall, and a covered arena behind the permanent stables (Images 2-3). The footing in these areas was also a clay base with sawdust. We observed the covered arena being watered and dragged prior to the evening session. A few exhibitors shared that the footing in Stopher Walk was deeper than usual.

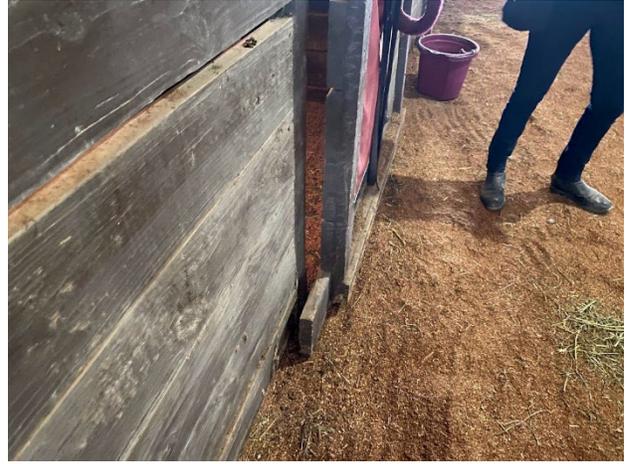
- **Stabling:** There are 16 permanent barns, five tent stables, and in addition, temporary stalls are located inside the North Wing at this facility. During the 2022 USEF Compliance inspection, some nails were observed inside stalls, and multiple doors did not have door stops at the bottom of the sliding doors in the permanent barns. This year, very few nails were observed, however door stops on multiple doors were still missing (Image 4), resulting in sliding doors that could be easily pushed outward at the bottom, creating a potential safety hazard for horses. There appeared to be sufficient electrical outlets and water sources in the permanent barns. Exhibitors shared they were generally satisfied with the permanent stabling.

**Image 4: Gap visible due to no door stop at bottom of sliding door in permanent barn**

13. Work with management to implement a solution to the numerous door stops that have not been addressed following each of the prior USEF Compliance inspections.

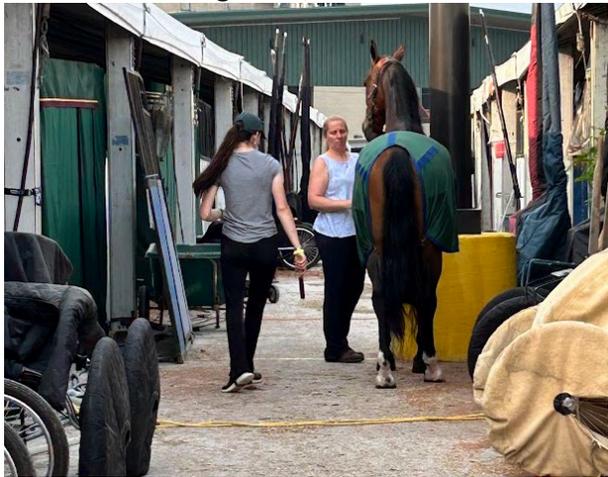
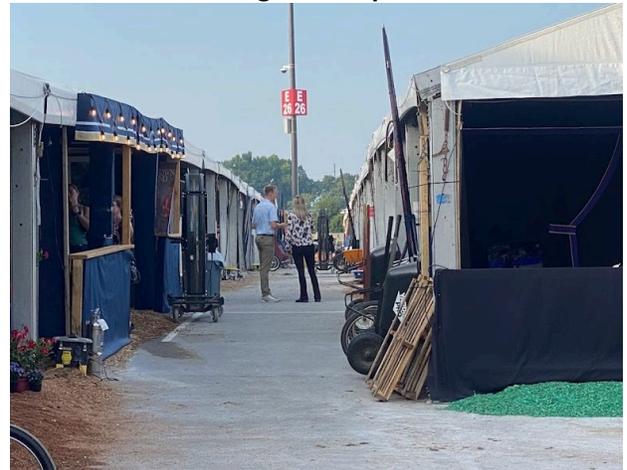
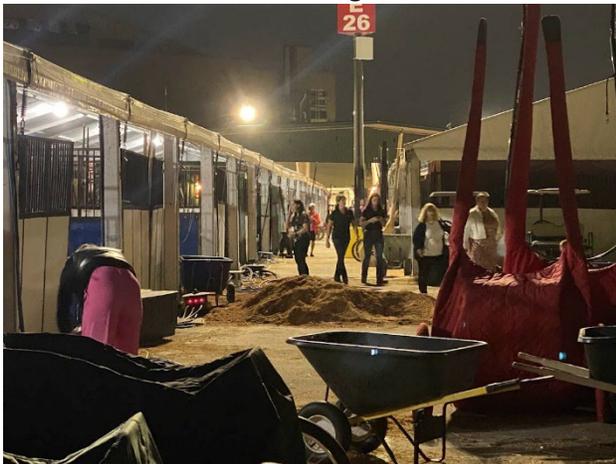
Four clear-span tents were provided on the parking lot outside of Freedom Hall. The aiseways between Tents A and B appeared to be narrow, especially due to exhibitors' trunks, carts and other equipment also lining the aisle, along with wash water runoff and electrical boxes (Images 5-7). The aisleway between Tents B and C was slightly wider, and the aisleway between Tents C and D appeared to be ideal, with sufficient space for multiple horses to pass and exhibitors' carts and trunks to be near their stalls (Image 8).

**Image 5: Aisleway between Tents A and B Tuesday morning**

**Image 6: Aisleway between Tents A and B Wednesday evening**

**Image 7: Aisleway between Tent A and B Wednesday night**

- Ensure Stewards coordinate the collection of the blood sample in case of any fatality or collapse situation.
3. Ensure tent stabling provides adequate space between each tent, specifically between Tents A and B, and B and C.

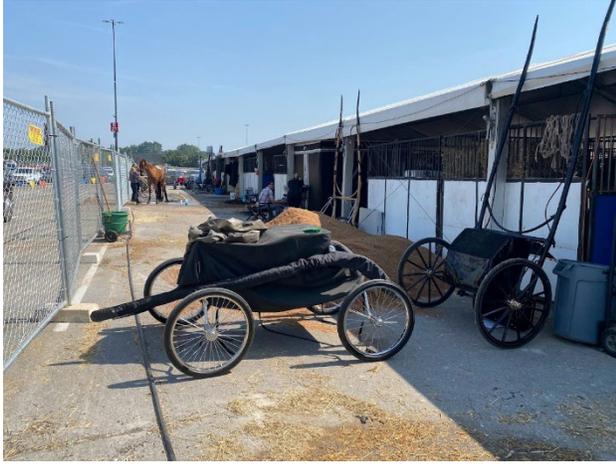
**Image 9: Far side of Tent D**

The temporary fence separating the tents from the parking area was placed approximately 8-10 feet from the far side of Tent D, resulting in space used by exhibitors to wash horses and store equipment (Image 9). The temporary fence, which appeared to be used to secure the enclosure for horses, was observed to have been opened/closed several times and in several locations, allowing for breaks in the fencing barrier around the temporary stables and manure to be dumped outside the fence (Image 10). The concern shared by an exhibitor with USEF the week prior to this show, regarding a narrow tent aisleway with only one entrance/exit, was not observed in any of the tent stabling we entered.

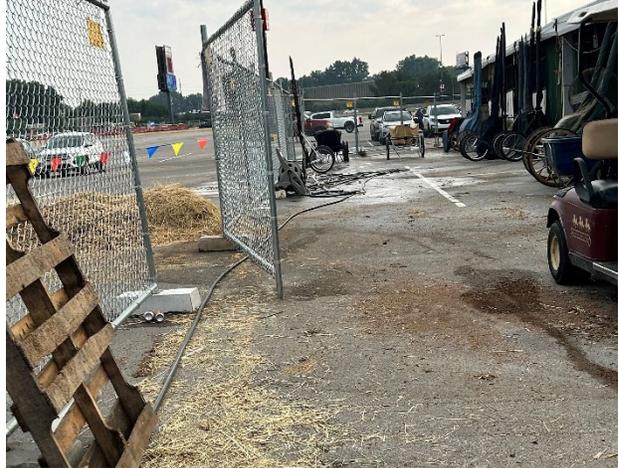
**Image 10: Fence opening on far side of Tent D; manure dumped on outside of fence**

6. For perimeter fencing surrounding the tent stabling, ensure it adequately secures the stabling area.
  7. Ensure horses are not occupying a stall with a tent pole.

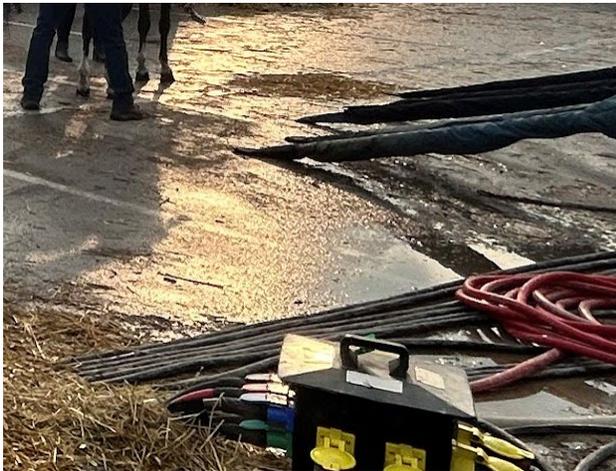
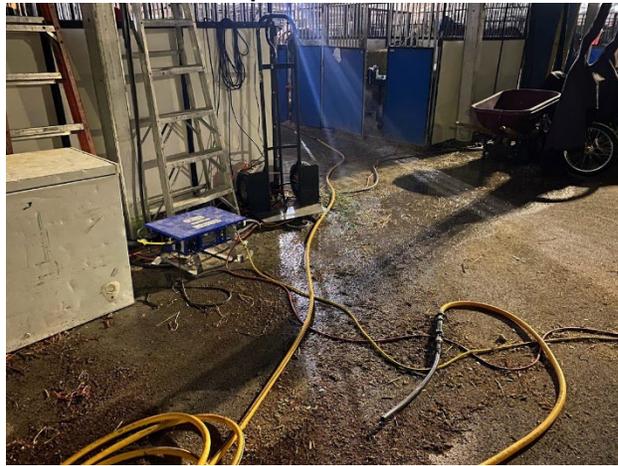
We learned from speaking with exhibitors that the generators for these tents had failed earlier in the week, and they were without power for several hours in the heat and were frustrated because this issue also occurred in 2022. Ms. Mattson shared that Kentucky Venues Executive Director of Operations, Mr. McCoy had replaced two generators this year, and both failed. Walking through these tents, we found TVs, air conditioners, decorative lights, and mini refrigerators appeared to be running all day, in addition to fans for horses. We observed multiple electrical boxes at the back side of the tents placed in areas where water runoff collected, resulting in wiring and hay mixed in wet areas (Image 11-12).

**Image 11: Electrical box adjacent to horse washing and mixed hay/detritus**

**Image 12: Electrical box at the back of Tent A adjacent to wet area**

4. Monitor tent stabling areas for appropriate electrical wiring to identify any potential fire safety or hazard to those walking in the stabling areas. For the duration of the event, ensure all electrical outlets and wiring meet the state and county fire codes.

14. Post the sample letter alongside the USEF MAAPP poster at the show office and ask that all participants read it upon checking-in.
  15. Designate wash areas in the tent stabling areas so that water runoff is routed away from electrical cords and stabling.

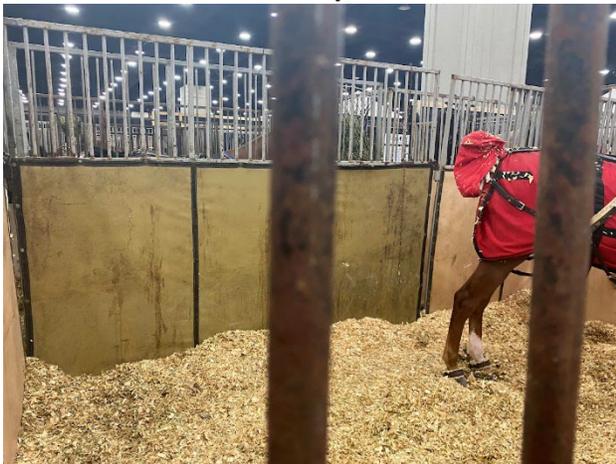
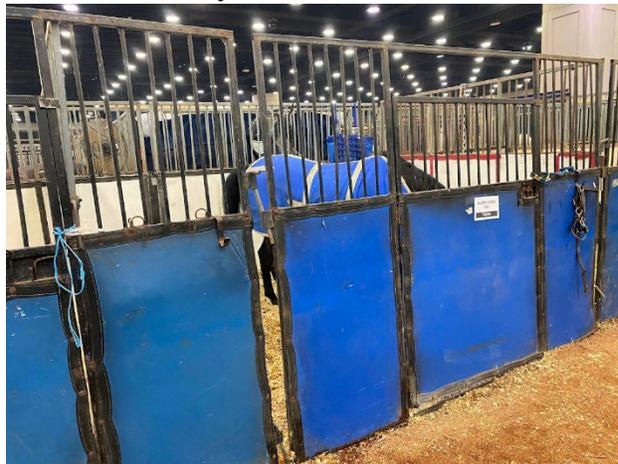
The temporary stalls inside the North Wing appeared to be older. Several exhibitors described their vinyl stall partitions as “filthy” upon arrival at the competition. Some vinyl stall partitions were torn. We understood from Ms. Mattson that the panels are cleaned prior to being set up, however, exhibitors shared a different experience (Image 13). We also observed some gaps between panels that may have been a potential safety issue (Image 14). Additionally, exhibitors pointed out to us that the sandpaper material underneath the shavings in some aiseways was beginning to show and was a tripping concern (Image 15).

**Image 13: Dirty stall partition, North Wing**

**Image 14: Gap between stall partition, North Wing**

11. Ensure manure is placed in designated containment areas and removal is timely and safeguard stabling areas from waste spread.
  12. Wash, sanitize and repair temporary stall partitions prior to horses moving in; this includes partition repair/cleaning, as well as ensuring door latches are functional.

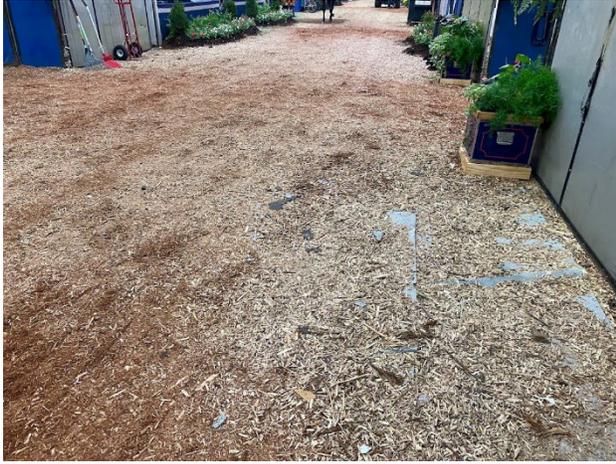
**Image 15: Paper coming up through the shavings in North Wing**

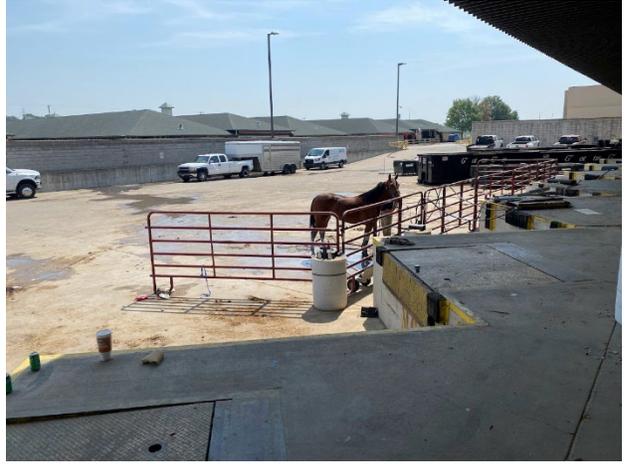
- **Wash Areas:** There was one large wash area designated with panel fencing and multiple hoses set up in the loading dock area of the North Wing (Image 16). There was no designated wash area in the permanent barns or tent stabling, and it appeared that exhibitors either walked to the North Wing loading dock/wash area, washed horses in the aisles of the permanent shed row-style stalls, or in the aiseways of tented stabling (Image 17). There appeared to be no drains in the tented stabling area so water runoff puddles in the heavily used areas, mixes with any refuse, and collects near electrical boxes (Image 18).

**Image 16: Loading dock wash area outside North Wing**

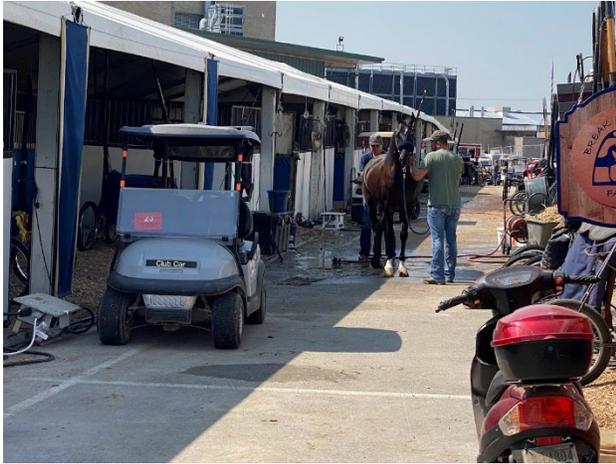
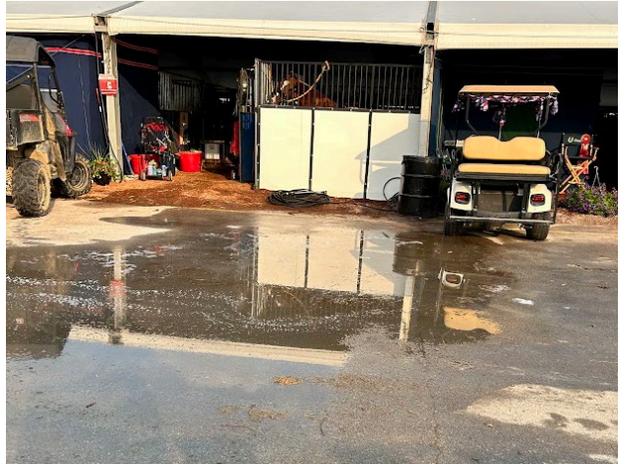
**Image 17: Washing between tents**

**Image 18: Wash water in tent stabling Tuesday morning**

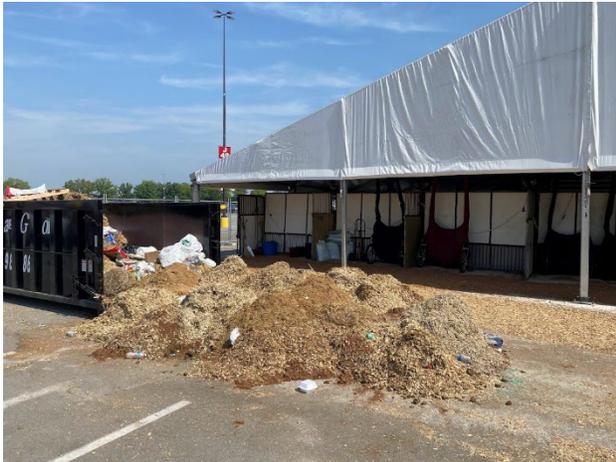
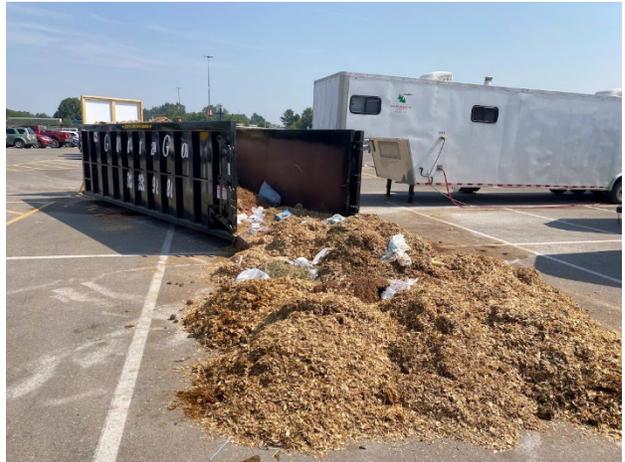
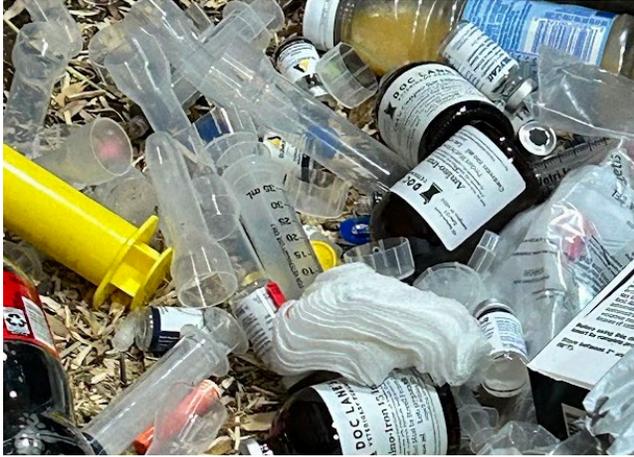
- **Waste and Trash Containment:** Upon our arrival Wednesday morning, we observed several dumpster containers in the tent stabling area that were not full, but the manure waste was piled into the walkways in the stabling areas (Images 19-20). We understood from Ms. Mattson that facility workers push the waste back into the containers with a skid steer, and once full, the containers are switched out for empty ones. We also learned that in previous years, exhibitors put manure in trash cans, making them very difficult to empty, therefore no trash cans are placed in the stabling areas and waste of every kind is intended to be collected in the dumpster containers (Image 21). Exhibitors in the North Wing shared that the manure container collection was inadequate. In the stabling areas outdoors, exhibitors shared that the removal of full dumpsters was extremely disruptive, and they would appreciate it if the containers could be removed during times of non-competition.

**Image 19: Dumpster in front of Tent D on Wednesday at 11:30am**

**Image 20: Dumpster behind Tent D on Wednesday at 11:40am**

**Image 21: Trash contents in a North Wing dumpster Tuesday afternoon**

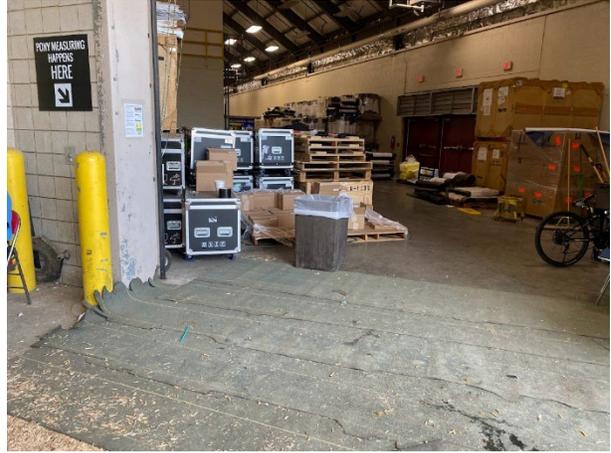
**Image 22: Measurement area**

- **Level measurement area:** A measurement area was provided inside the North Wing stabling area. It was designated with signage and sandpaper material was placed over the concrete (Image 22).

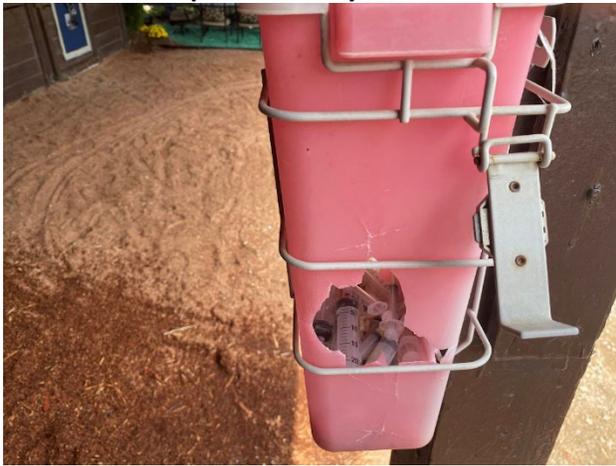
- **Sharps Containers:** We observed that most sharps containers were compliant with USEF requirements outlined in GR1210.4. However, one container in permanent Barn L had a large hole in the side, and one container in Barn G had collected rainwater (Image 23), and when we spoke with the USEF Stewards, they were unaware of this non-compliance with the rule. Similar to 2022, there were a few sharps containers which were on the external pole of barns increasing the likelihood of collecting water during rainstorms.

**Image 23: Broken sharps in Barn L**

9. Ensure that all dogs are held on a leash or otherwise restrained as per GR 1301.6.
  10. Make certain all sharps containers are placed out of the elements and that all are in compliance with GR 1210.4.b.
